Audi A2 1.4 AUA Petrol Starter Motor Removal

This guide details how to remove the starter motor from an Audi A2 1.4 AUA petrol and is based on the procedure described in the [Workshop Manual](#).

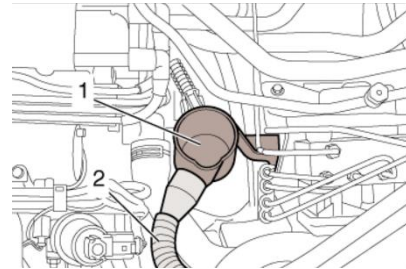
2. Remove the water collector which is positioned on the right side of the engine bay just above the gear selector tower/linkage and attached via a 10 mm socket to the ABS unit. You will need a socket extension for this. Once disconnected, it can be re-positioned out of the way behind the right hand headlight

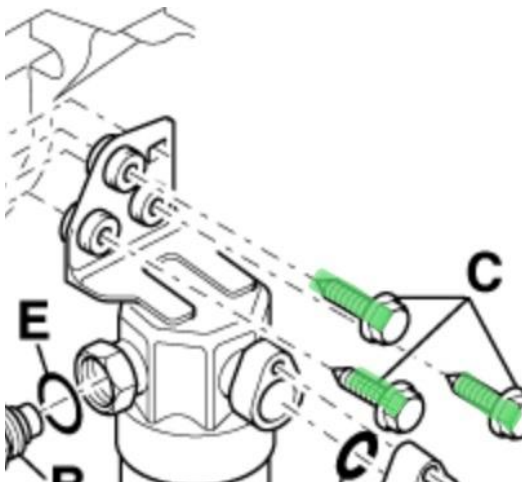
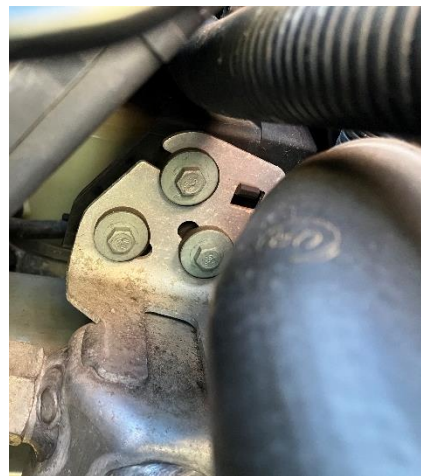
3. Remove the three bolts securing the air conditioning collector to allow it to be moved a bit if needed. It is positioned on the right hand inner wing just in front of and below the ABS unit. This needs a 10 mm socket and a longer socket extension.

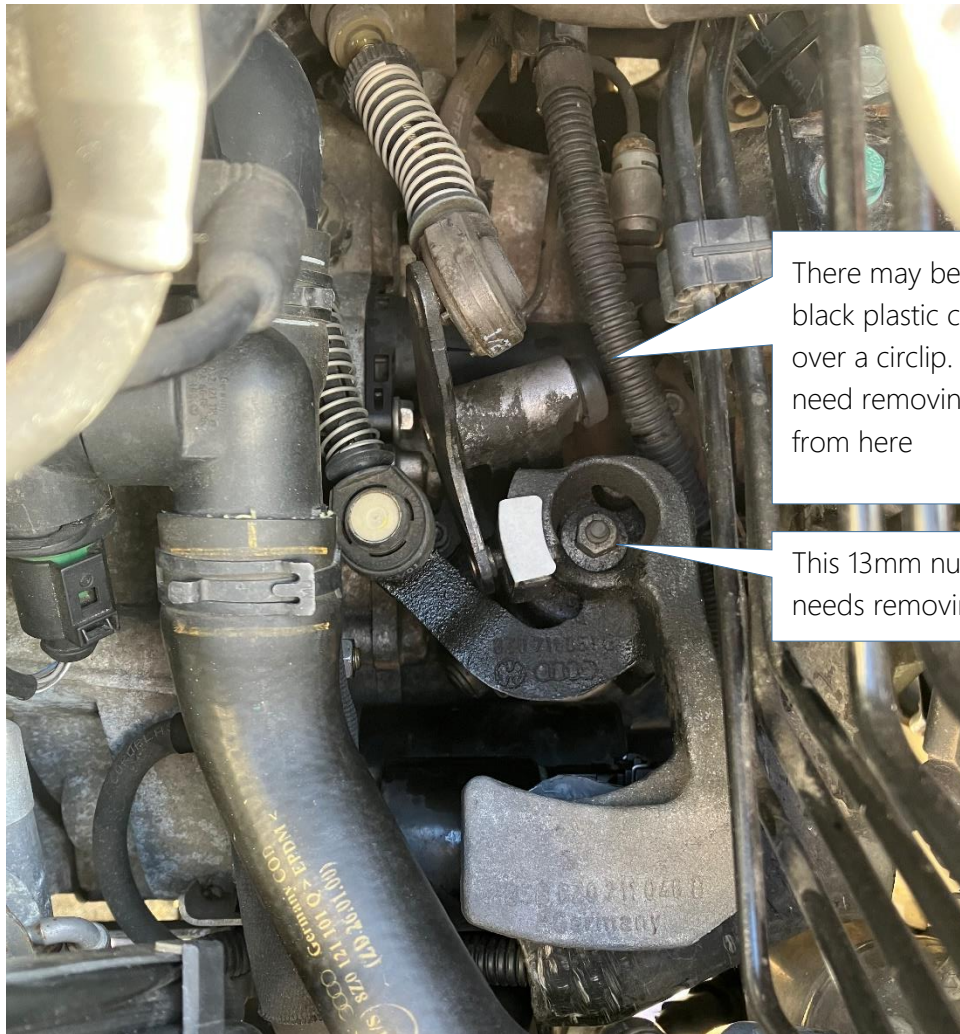
4. Next up you need to remove the gear selector linkage counter balance from the selector tower. This is held in place by a nut and will require a 13mm socket to remove. With this nut removed, all the videos I found showed sharp yanking upwards on the counter weight would release this from the splines. Despite 2 weeks of spraying with PB Blaster this was having none of it!

There may be a black plastic cover over a circlip. Both need removing from here

This 13mm nut needs removing

When fitting the gear selector counter balance back onto the selector shaft splines, two of the splines have been merged into one to ensure correct location, so double check you have this correctly lined up before gently tapping it into place. I found out after the event that the 13mm nut that holds this in place should be replaced, so I did that retrospectively

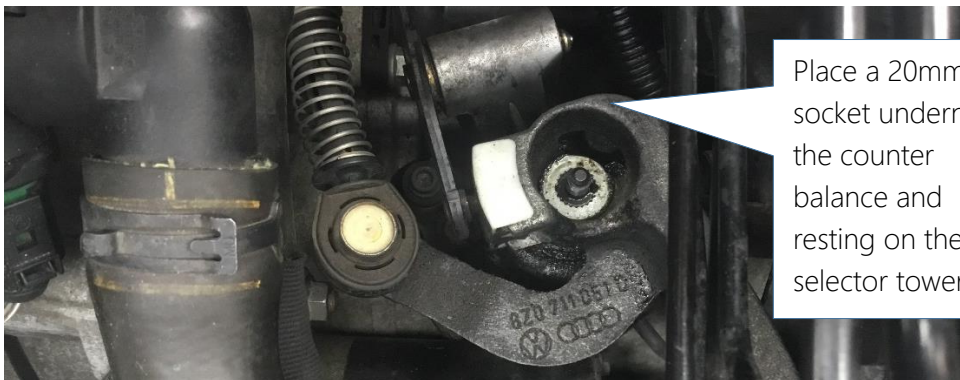
Place a 20mm socket underneath the counter balance and resting on the selector tower

I found a single entry on a VAG forum that suggested placing a 20mm socket between the selector counter weight and the top of the selector tower to raise it up a bit and prevent downward movement. Then screw the 13mm nut back on, but not fully. You can then place a long socket extension on top of the nut and hit sharply with a hammer. Go carefully - not too hard - but this did eventually release the counter weight from the splines. It is then possible to position this counterweight out of the way to gain access.

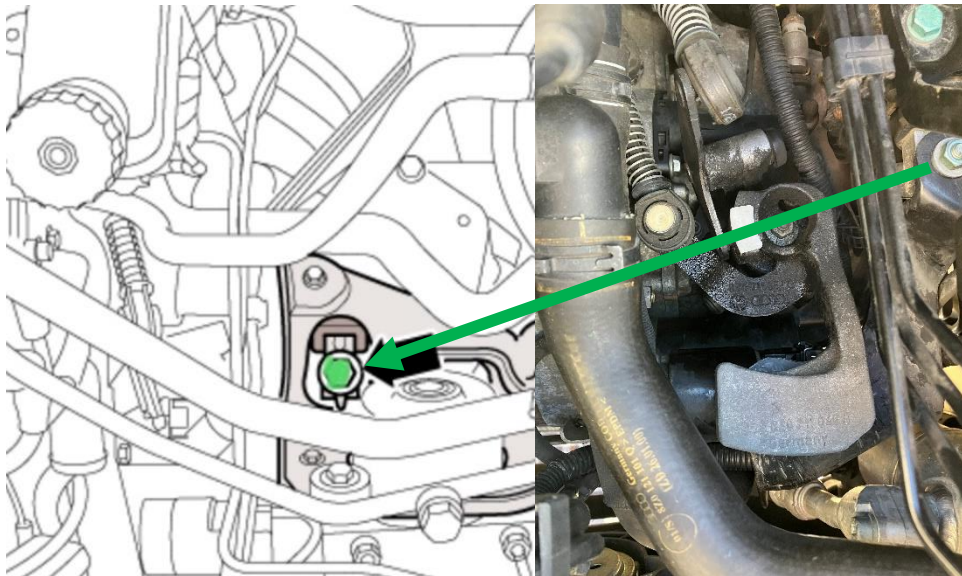
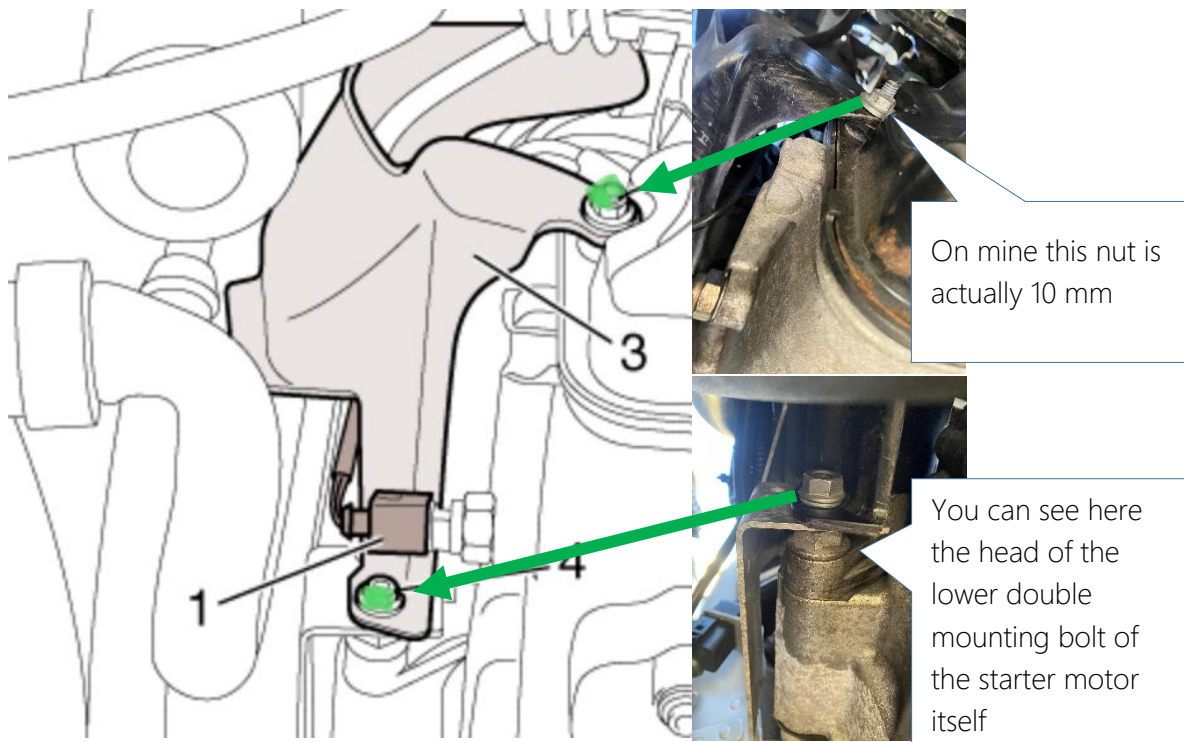
5. The next step is to remove a complex thick plastic cover that covers the power connections to the starter motor, one accessible from the top of the engine bay and two from underneath. They are pretty accessible and removed with a 13mm socket.

6. The same cannot be said of the cover itself! The manual says just push it aside and eventually remove. Well I wiggled and jiggled it and found I just couldn't find a position for it that made this possible. It is made of quite thick hard plastic so just getting it clear of the underbody bolts

was pretty tough. It maybe with higher ambient temperatures this might have had more flex but at 12 degrees and with arthritic hands it was beyond me.

My solution? Very amateur I'm not proud to say; I cut off one of its 'legs' and then was able to pull it clear. In my defence I found one on eBay for £5 before doing this so will look at fitting the cover back retrospectively.

Note: The arrangement for the diesels seems to be much simpler. Given that - from what I can see - this cover is to prevent spray getting to the electrical connections of the starter, I am going to look at fabricating a simpler arrangement or whether the diesel cover can be used.

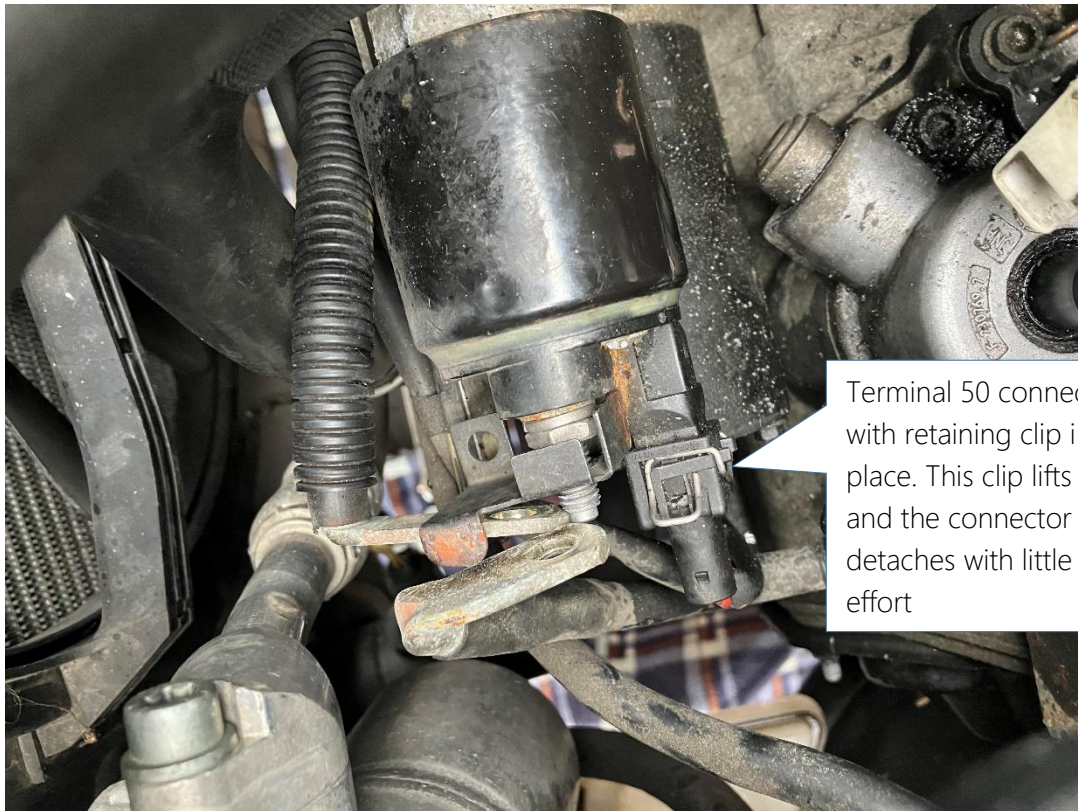
7. So now that the starter motor can be got at, it is fairly straight forward. First disconnect the battery. Then you can disconnect the power and control to the starter motor. In the photo below you can see the bolt removed and the order in which the two cables and the anti rotation bracket are fitted. These need to be removed and pulled clear and the Terminal 50 connector detached.

Terminal 50 connector with retaining clip in place. This clip lifts off and the connector detaches with little effort

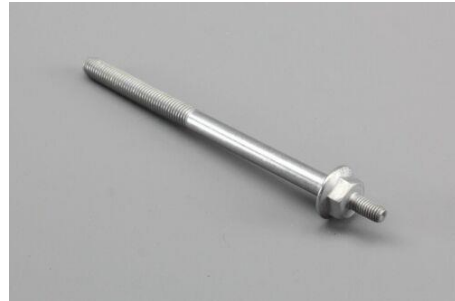
8. Next remove the lower starter motor bolt. I have shown this in an earlier picture in item 5. The nut that holds the protective cover in place has already been removed and you will need to slide a connector mounting bracket off the bolt to fully expose it. To remove the connector bolt you will need an 18mm socket.

This will need to be quite tall so that it clears the double element of this bolt. The picture to the right shows what one of these bolts looks like when removed. It will give you an idea of the size of socket you will need.

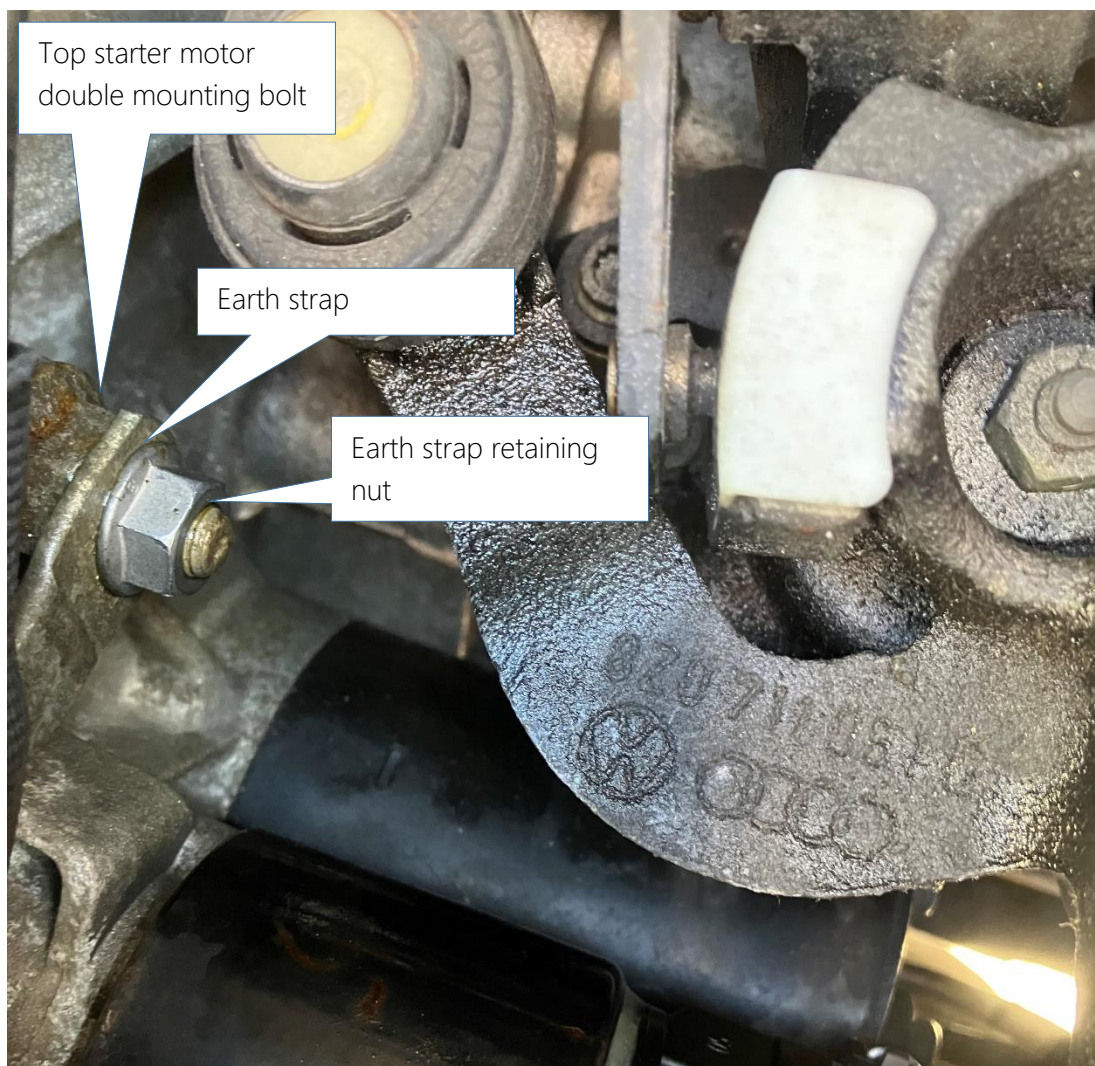
9. Home straight now. The picture below shows the starter motor top mount double bolt. The nut you can see is 13mm and connects an earth strap to the engine. This picture was taken before any of the previous steps had been undertaken but it shows the location clearly

You need to remove the 13mm retaining nut and pull the earth strap clear. I took the opportunity to give it a good clean up. You then have access to get your tall 18mm socket and remove the top starter motor retaining bolt.
